# EVALUATION OF PROTECTIVE COATINGS FOR CONCRETE

December, 2004 Final Report

County Sanitation Districts of Los Angeles County, Whittier, California

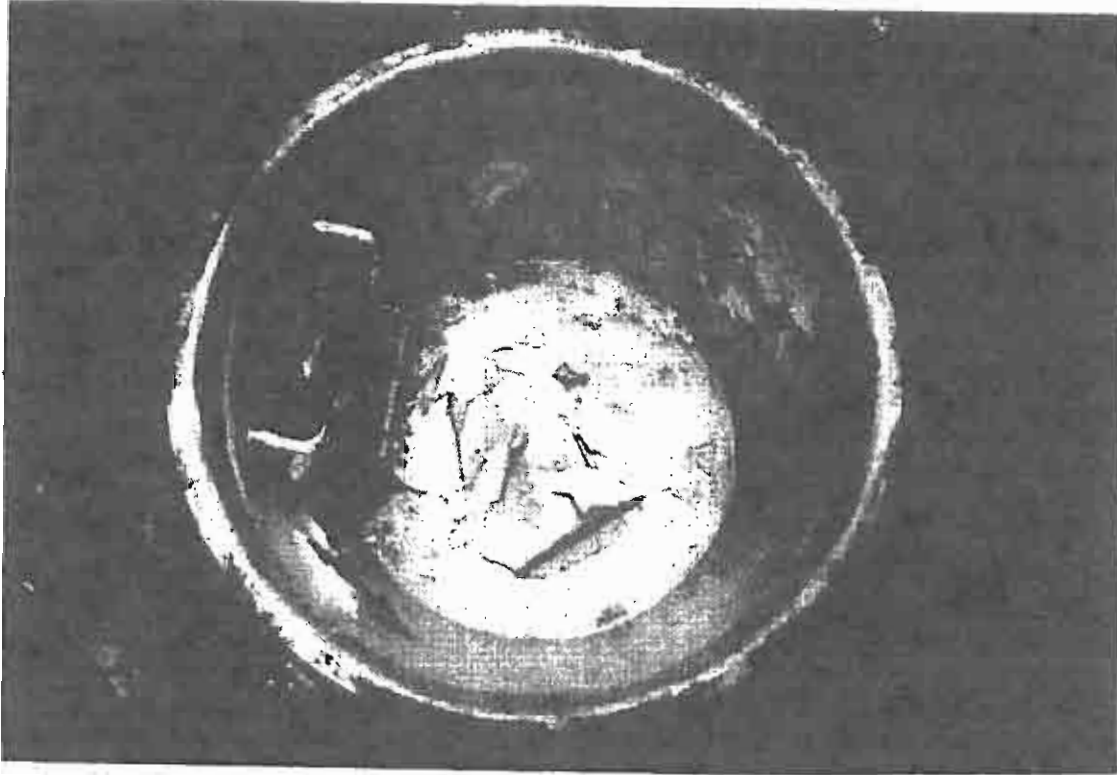
Figure 7 illustrates the coating failure that occurred after only a short time period to one epoxy coating (C-7). Preliminary tests with ingots of one system (C-23) looked promising, but the manufacturer decided to use a non-epoxy coating system in the evaluation. Lack of sufficient acid resistance and inability to protect the concrete from corrosion plagued the other systems (C-14, C-19, and C-21).

Figure 7. Epoxy coating failure.
