# EVALUATION OF PROTECTIVE COATINGS FOR CONCRETE

December, 2004 Final Report

County Sanitation Districts of Los Angeles County, Whittier, California

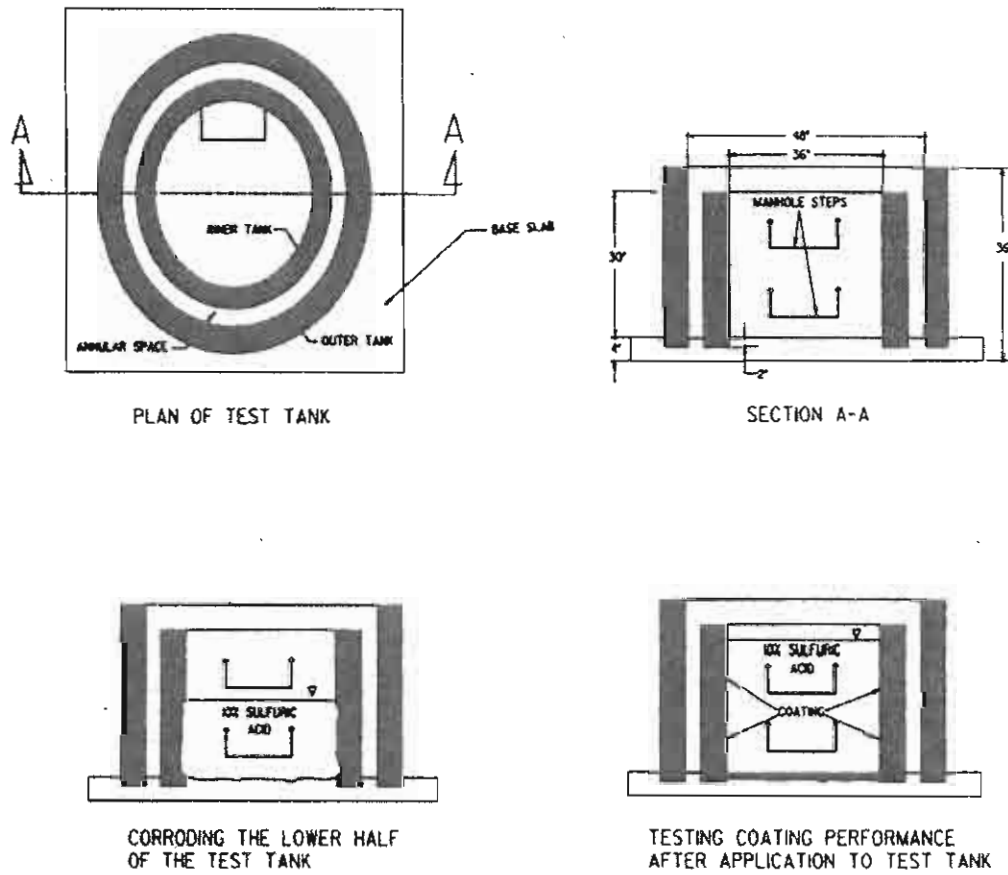
Figure 2. Construction of test tanks and sequence of coating testing.

The coating to be tested had to be able to cure sufficiently so that water could be added to the test tank within 48 hours after the application. A total of 96 hours after the application of the coating, sufficient concentrated sulfuric acid was added to the water in the test tank for a final acid concentration of 10% by weight. The acid level in the coated test tank was set high enough to also submerge a portion of the coated uncorroded concrete. This is illustrated in Figure 2.

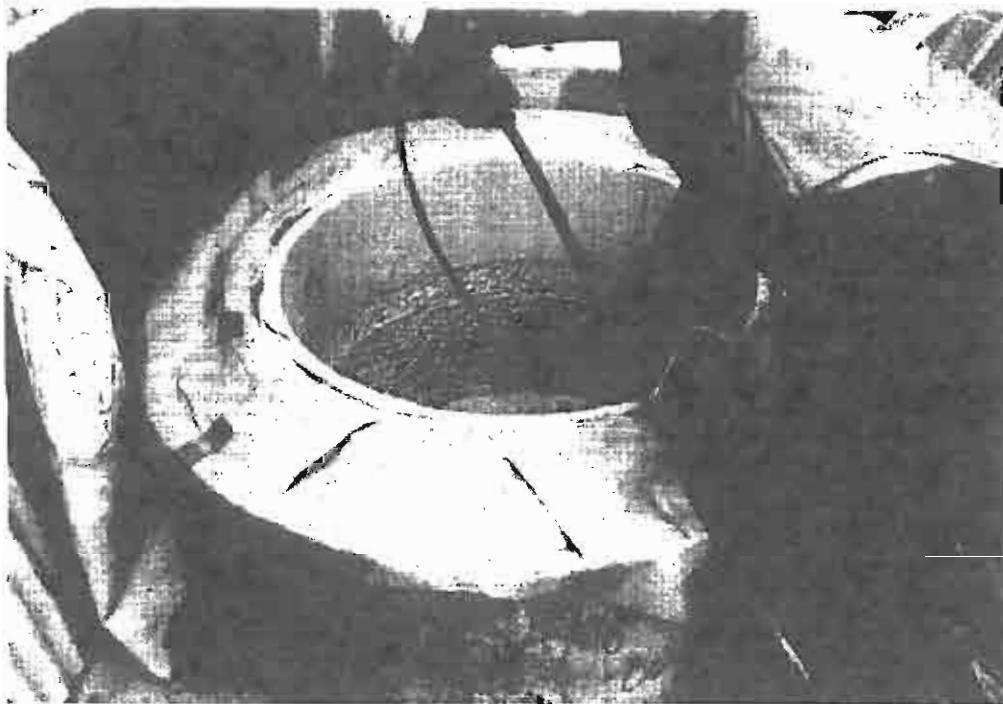
Figure 6. Spraying a coating on a test tank.
